DOCUMENTATION OF ENVIRONMENTAL INDICATOR DETERMINATION

Current Human Exposures Under Control

Facility Name: Bulova Technologies LLC

Facility Address: 101 North Queen Street, Lancaster, PA 17604

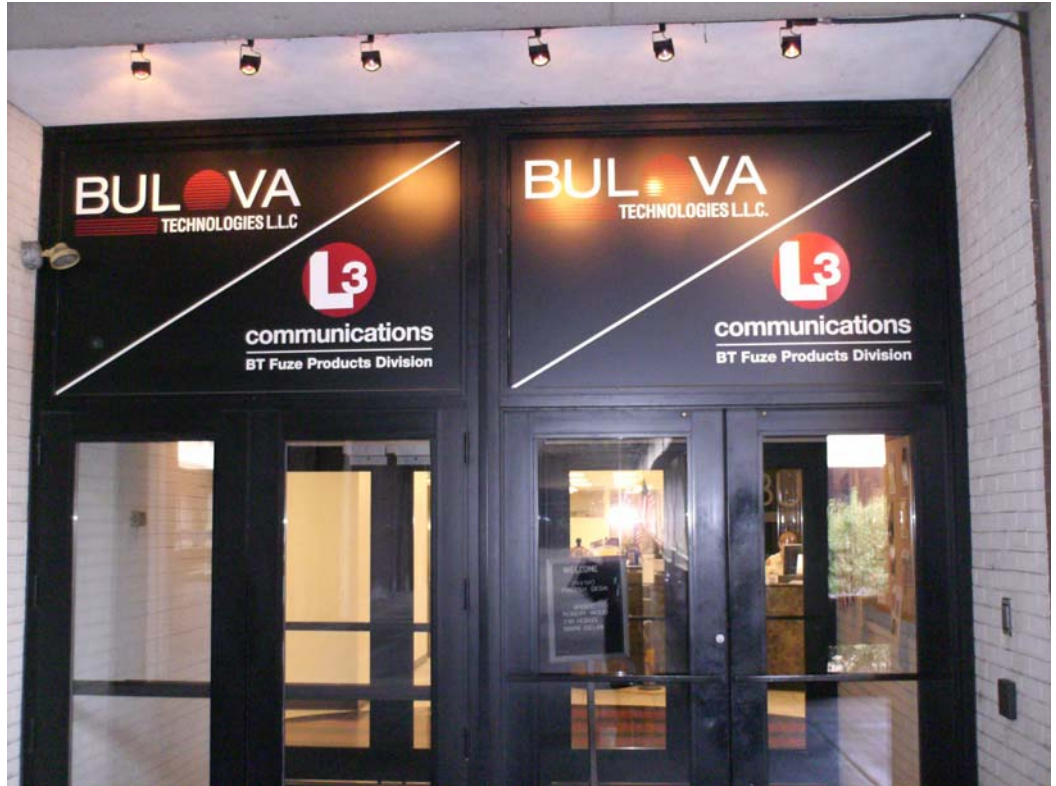
Comments: Active Bulova Technologies facility located at 101 North Queen Street Lancaster, PA.

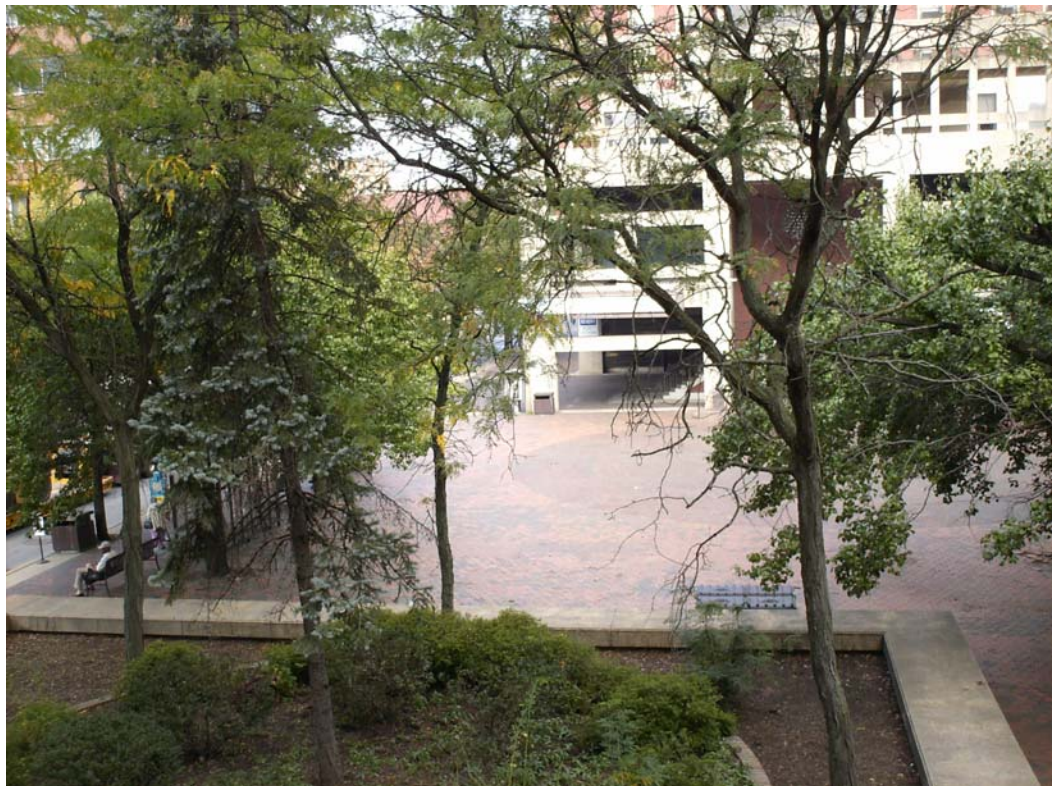
Comments: The facility is bordered in all directions by commercial businesses in downtown Lancaster.

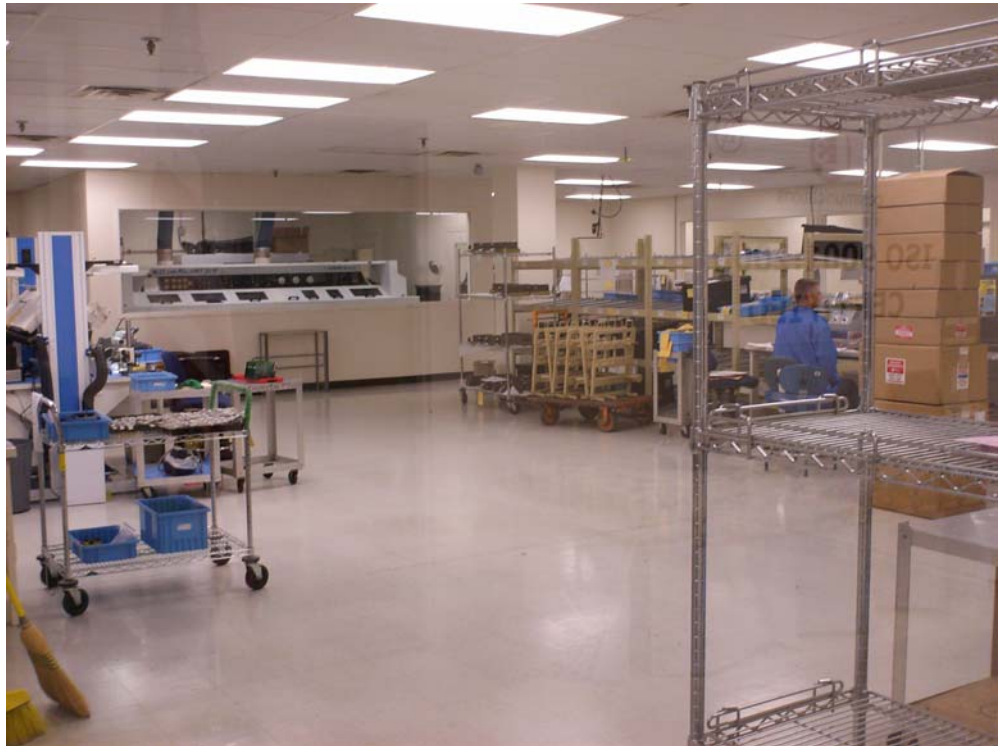
Comments: Second floor laboratory for assembly of printed wiring boards.

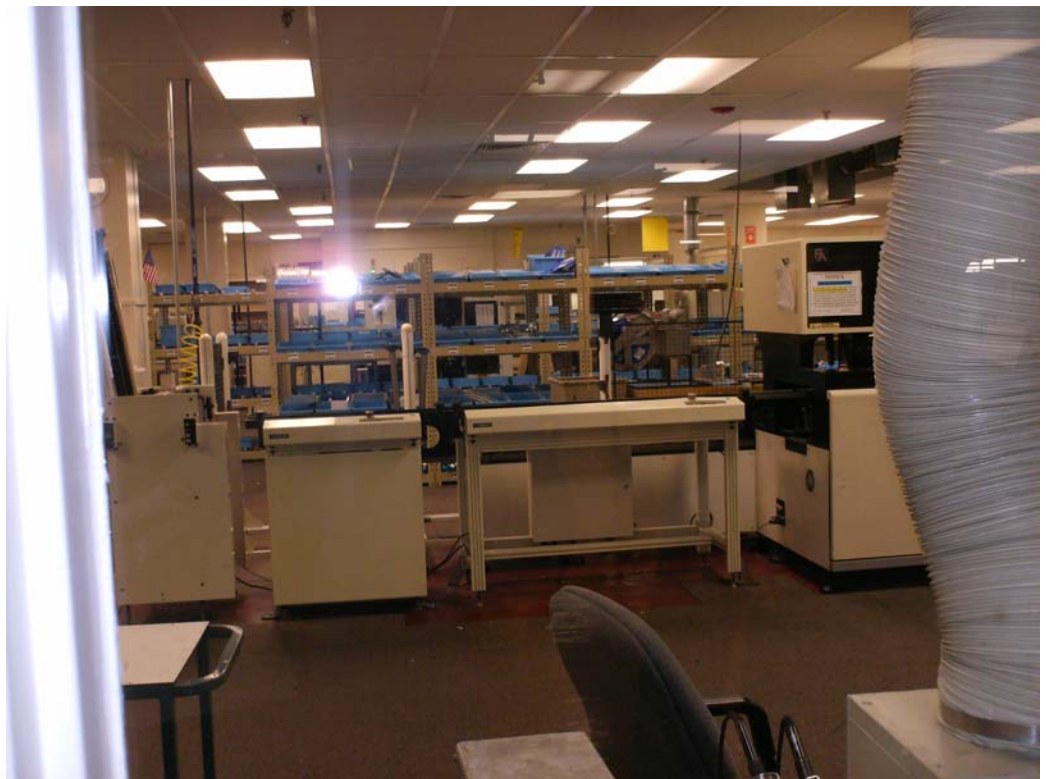
Comments: First floor laboratory for assembly of printed wiring boards.

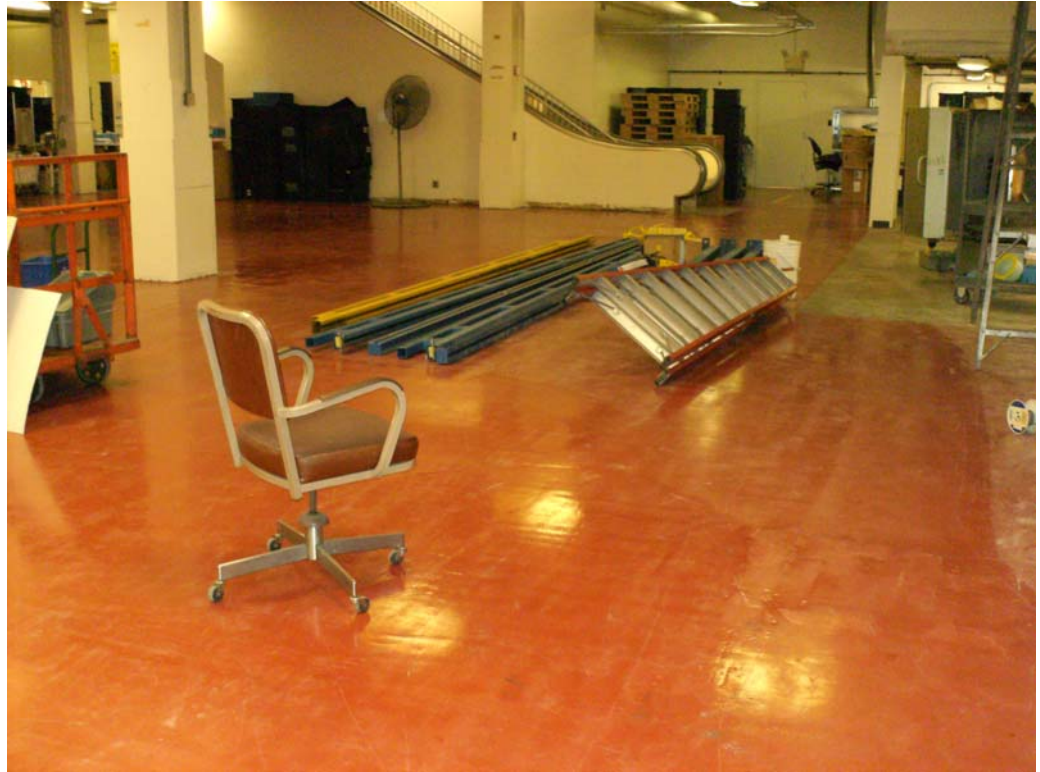
Comments: Former plating area. The area remains vacant for future tenants.

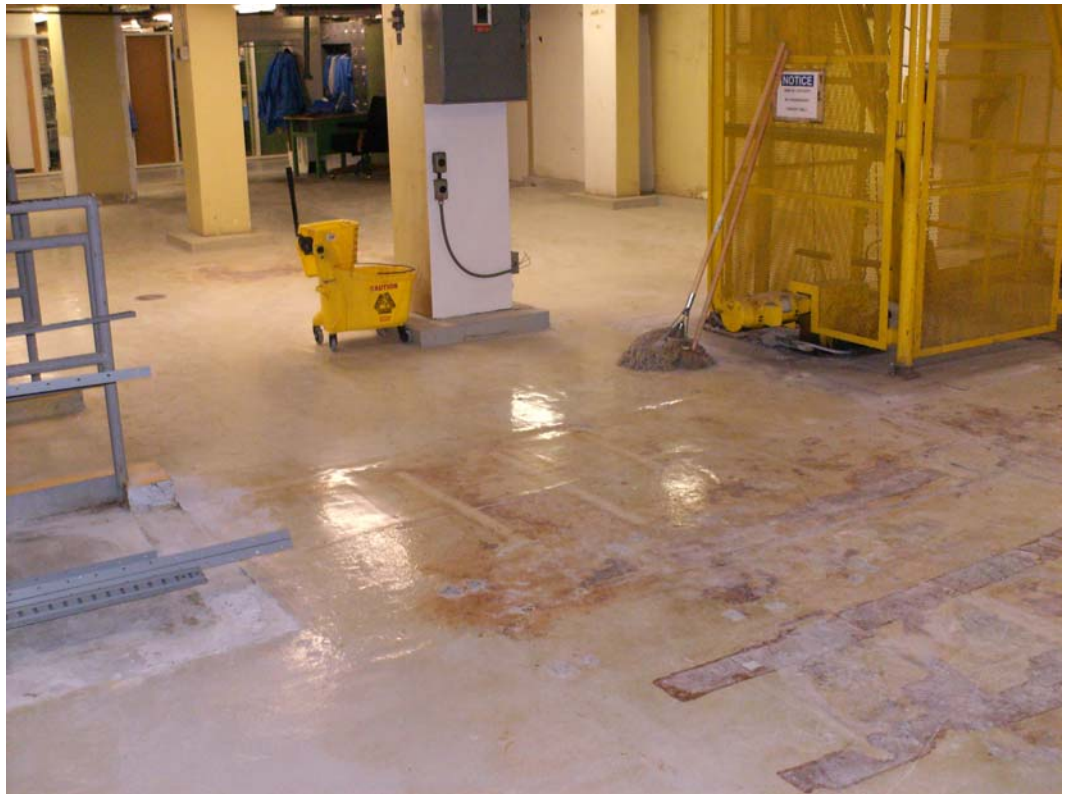
Comments: Former plating area. The area remains vacant for future tenants.

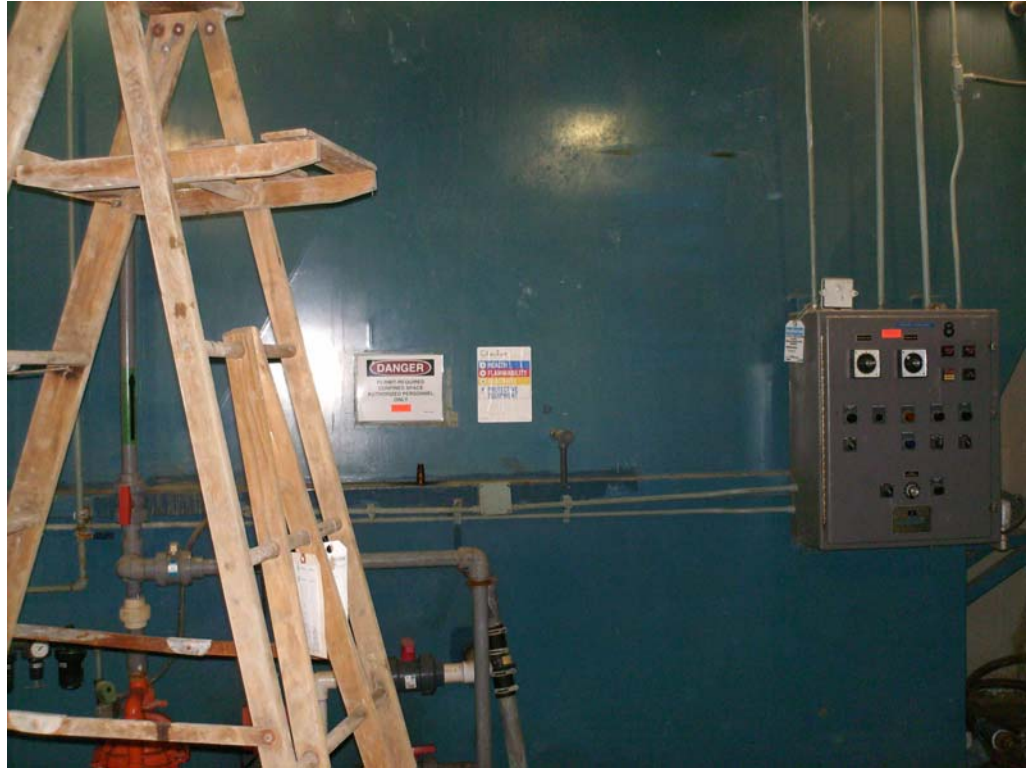
Comments: Clarifier in SWMU 1, Wastewater Treatment Room.

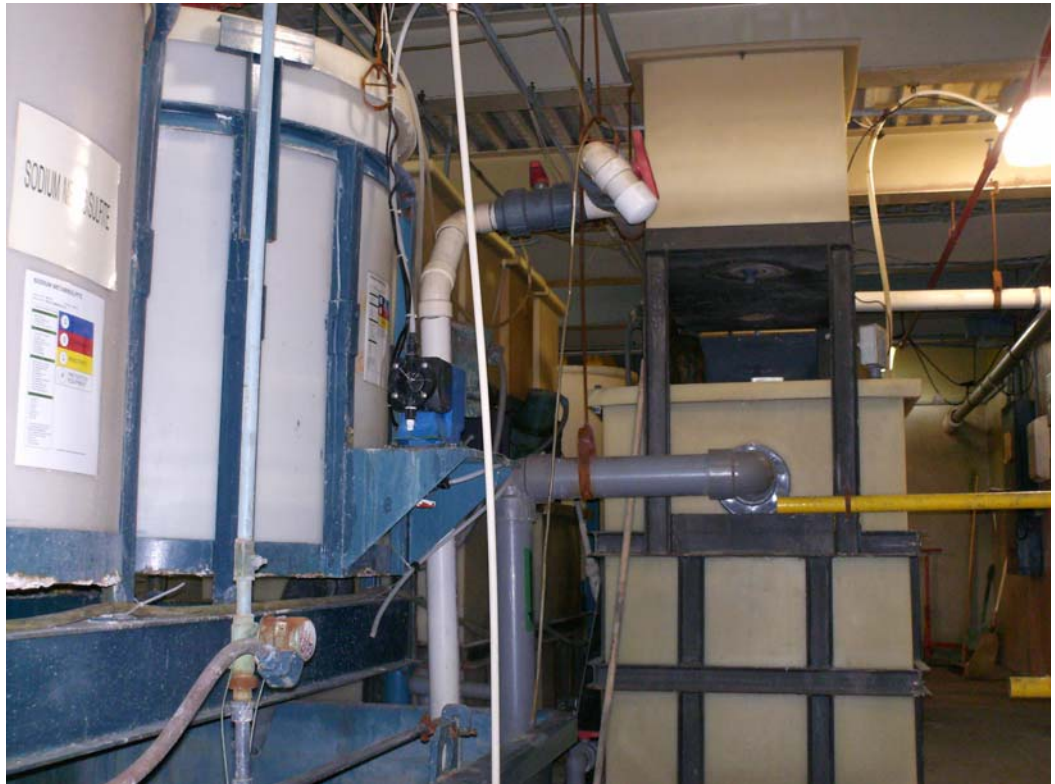
Comments: Several empty tanks in SWMU 1, Wastewater Treatment Room. The Wastewater Treatment Room only receives one waste stream from one parts washer.

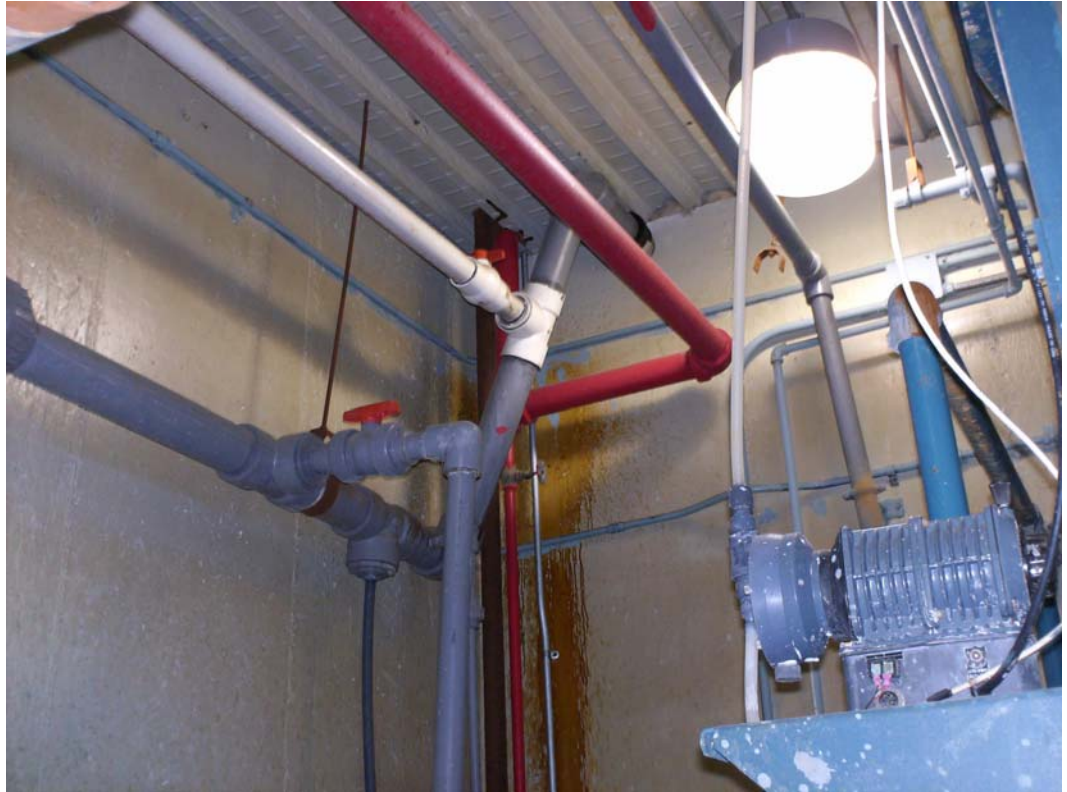
Comments: Gray piping in SWMU 1 that discharges to the city. Bulova monitors the discharge monthly and submits a quarterly report. There have been no instances of non-compliance.

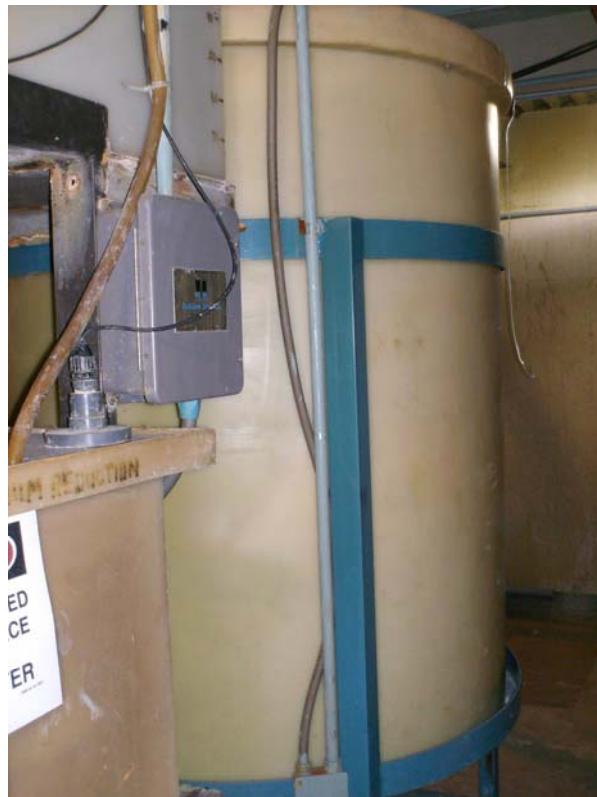
Comments: The only active tank in SWMU 1 that receives waste from a parts washer.

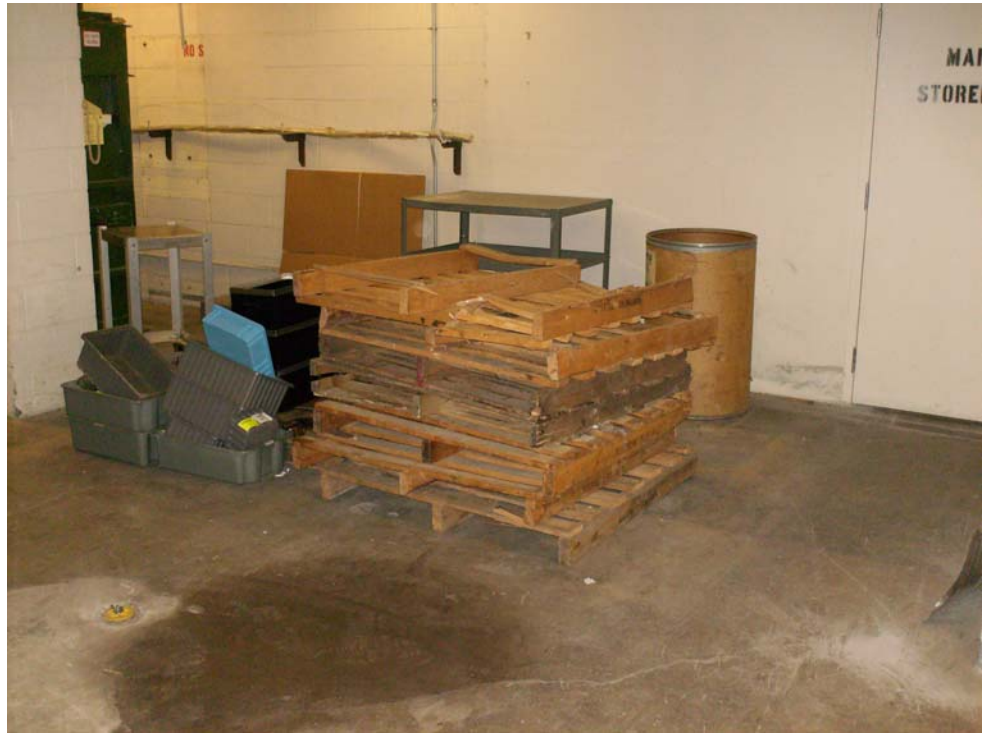
Comments: Former location of SWMU 3, Filter Press. The area is currently used for miscellaneous storage.

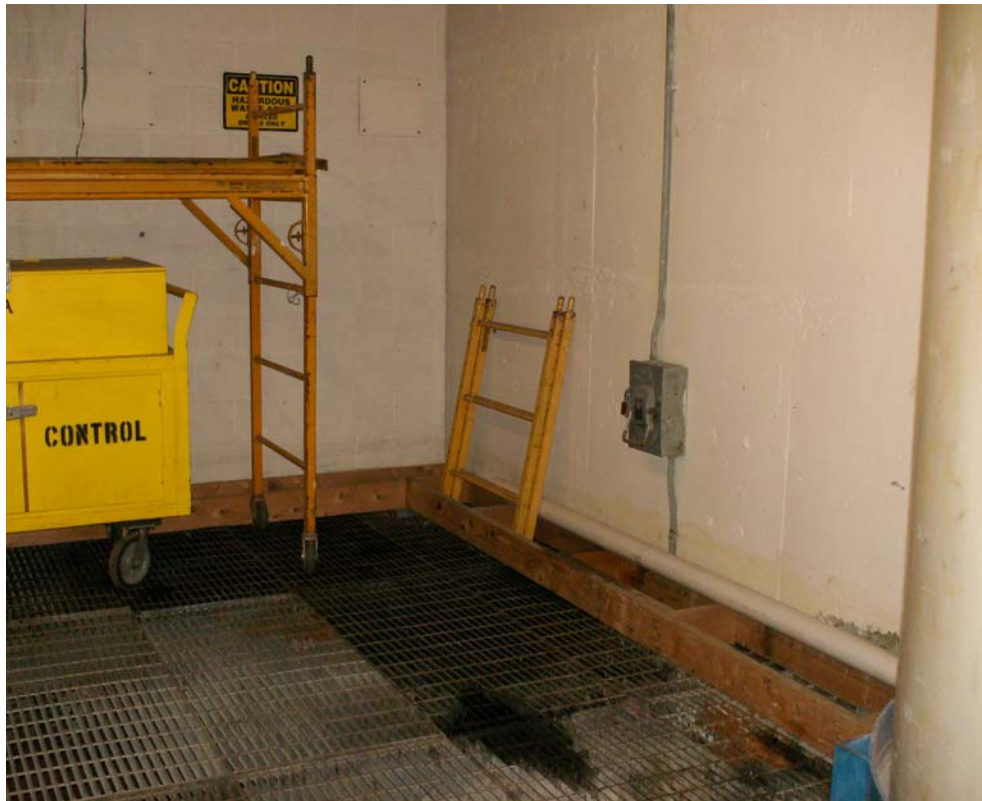
Comments: Former SWMU 2, Electroplating Sludge Tank beneath the grating. This area is in SWMU 4, Waste Solvent Storage Room. The tank is no longer used and the room is currently used for storage.

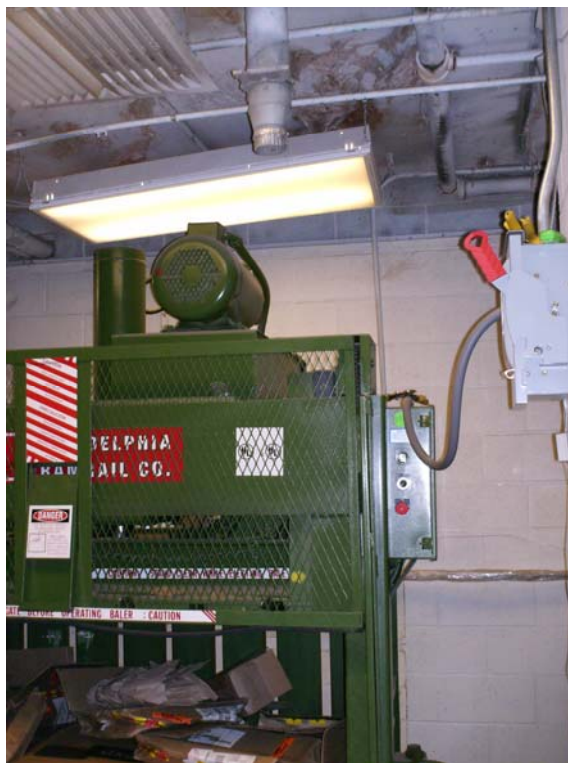
Comments: Former location of SWMU 5, Solvent Recycling Still. Ventilation is still present in the ceiling.

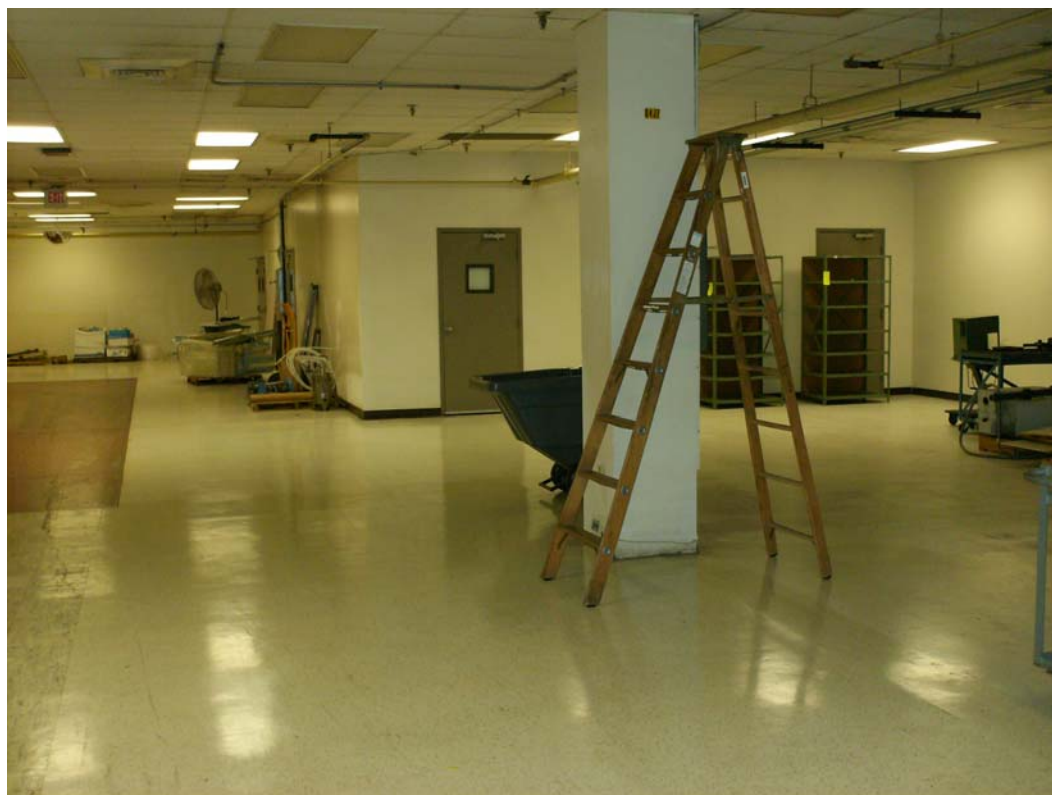
Comments: Vacant 3rd Floor.

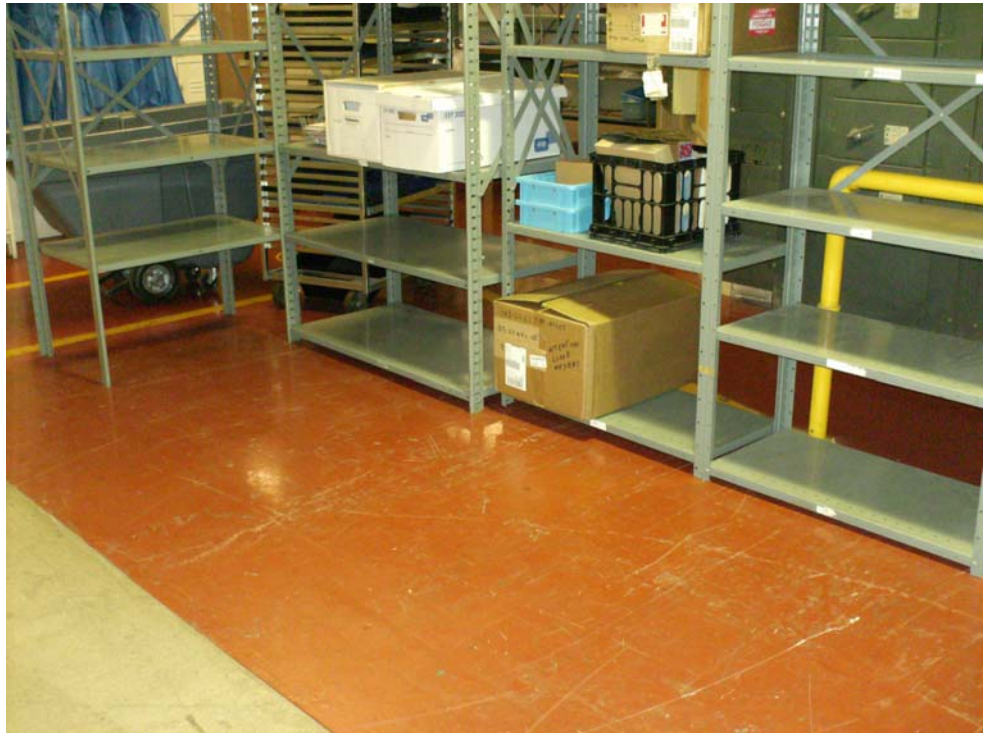
wastewater treatment system. The facility had a 2,000-gallon UST, which was installed in 1971 and removed from service in 1982. The UST, which contained No. 2 fuel oil, was located in the basement of the building. On December 4, 1995, the PADEP reviewed the closure report and found it acceptable. PADEP indicated that since the extent of hydrocarbon impact appears minimal, no further action was necessary.

Comments: Former location of closed UST.

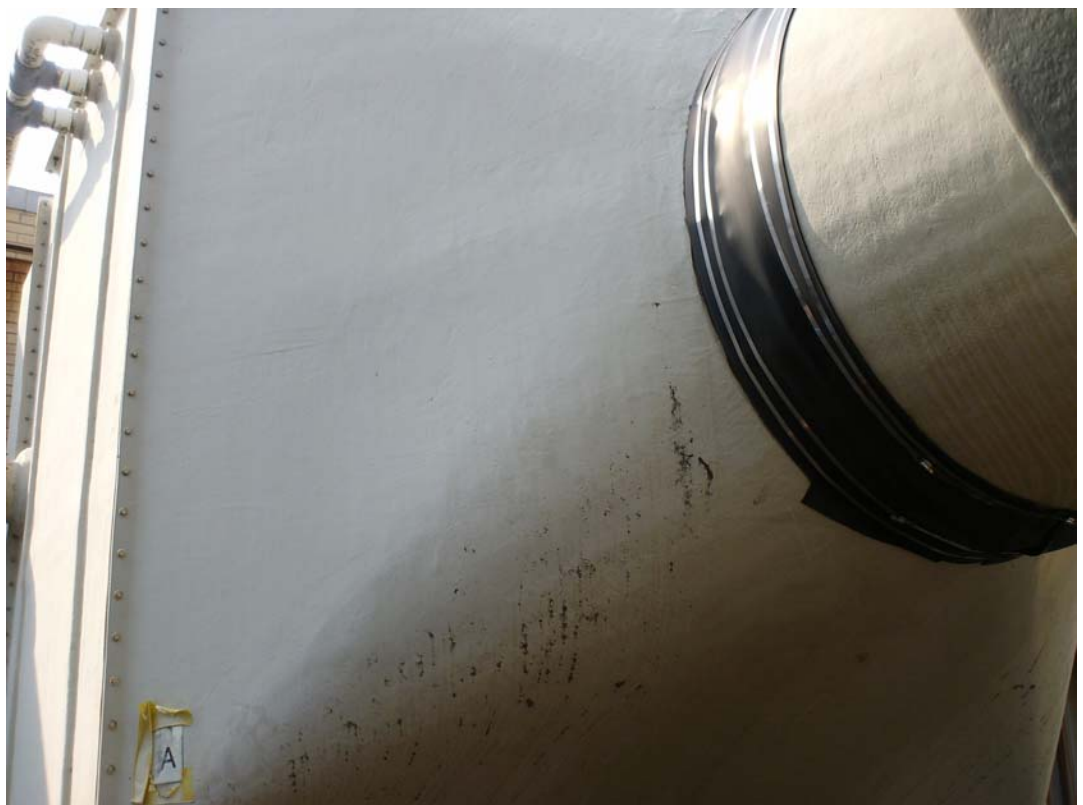
On February 12, 2003, PADEP notified the facility that it was in violation of the Air Pollution Control Act because the re-circulating pump on the Heil Packed Tower Scrubber had been deactivated due to the structural failure of the unit's Mist Eliminator. On May 22, 2003, the facility sent a letter to PADEP explaining the reason for the malfunction.

Comments: Former SWMU 6, Air Scrubber. The unit is no longer active. All air permits have been relinquished.
